Brecknock Manor House

Images

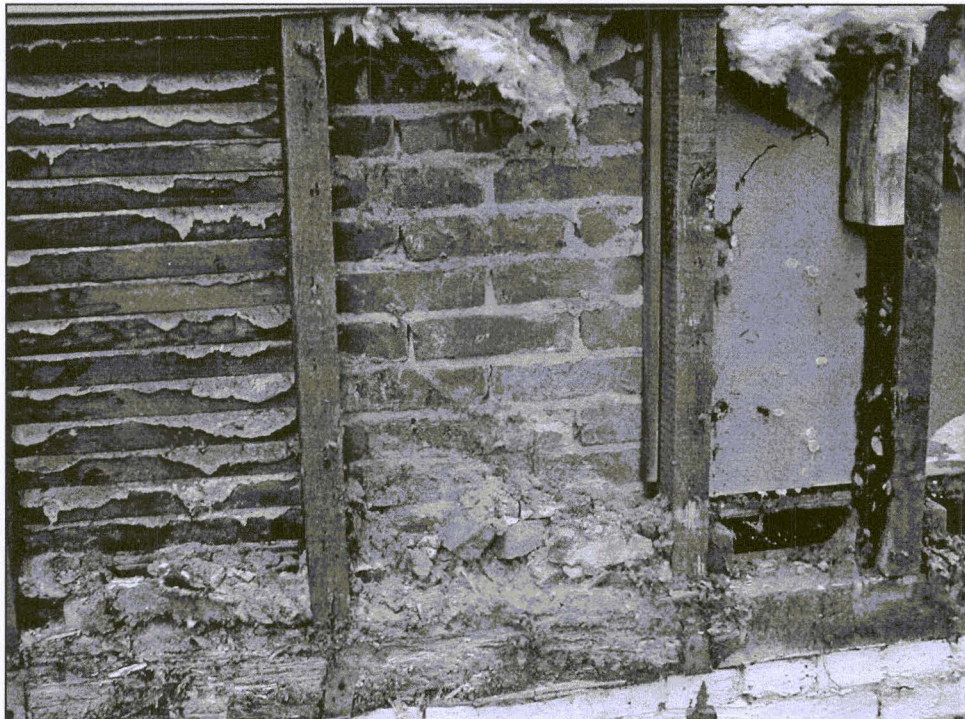
Figure 15. Several wall materials were exposed during the rehabilitation, summer 2000: (R to L) lath, brick chimney stack, and dry wall supported by studs and a deteriorated sill plate.

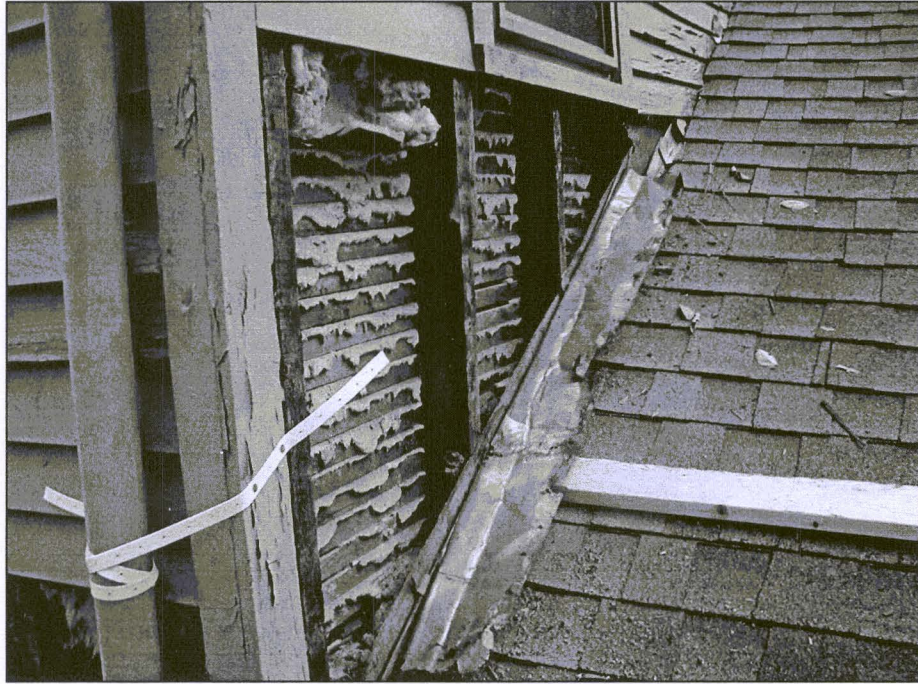
Figure 18. The corner post in the foreground marks the area of most concern. The interior wall of this room is severely marred by stress cracks and fissures in the plaster, indications that this corner of the building is settling. Efforts were made in 2000 to investigate the cause of the structural stress.

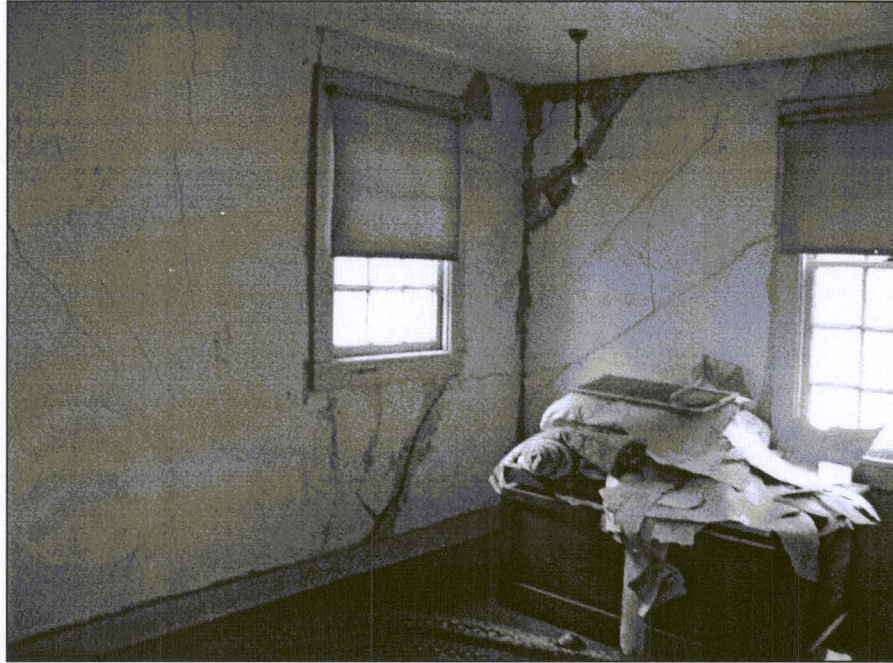
Figure 42. Period 4, second floor (rear room). This room displays the most evidence of structural stress. Measurements of these wall fractures indicate that building's foundation may be settling.

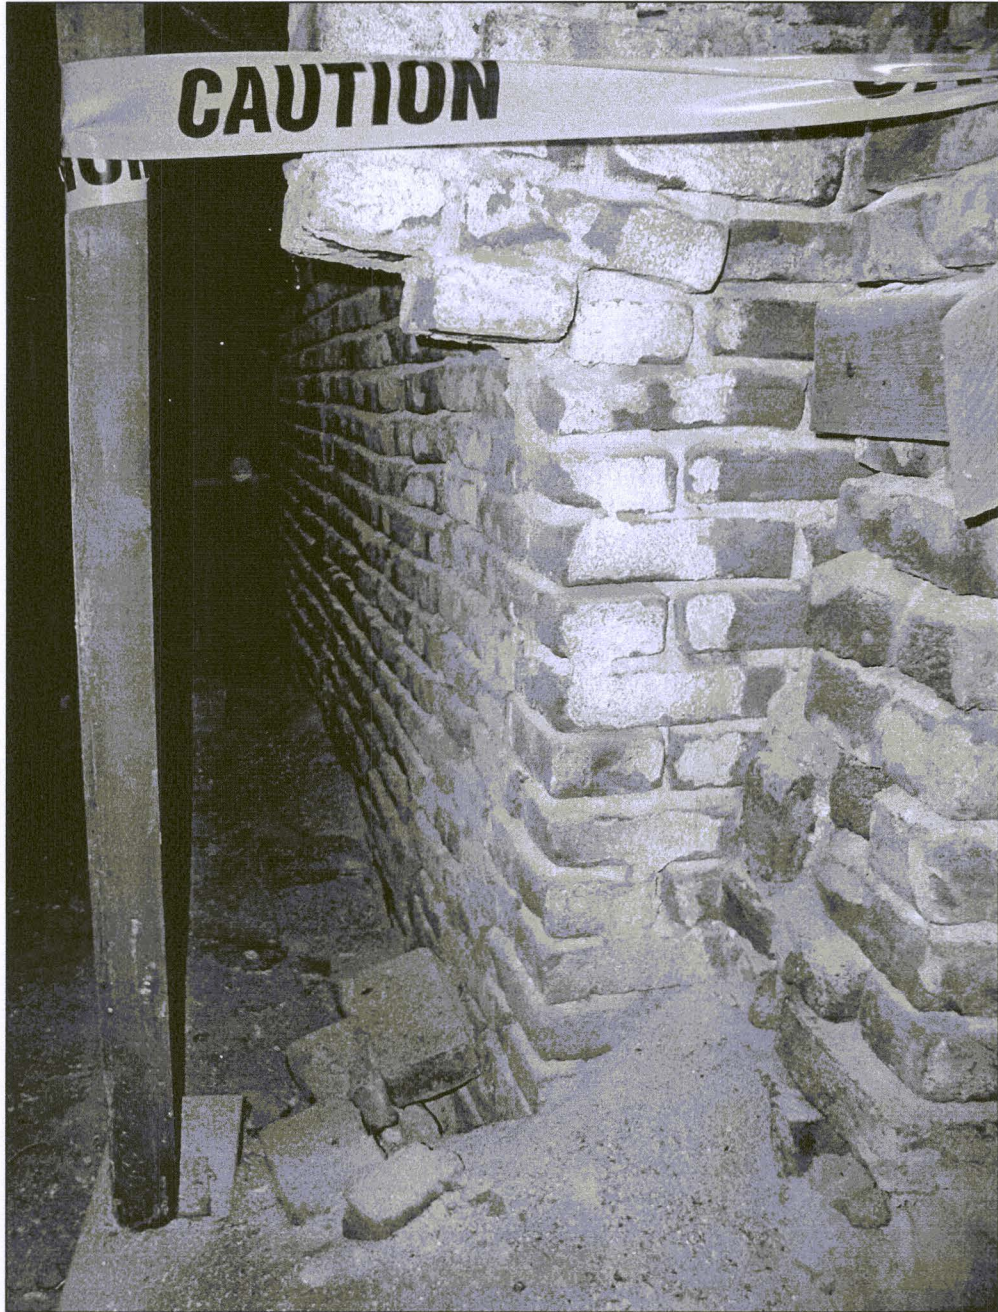
Figure 46. This curious cantilevered wall section in the basement appears next to an abutting wall, mortar dust, and fallen brick.

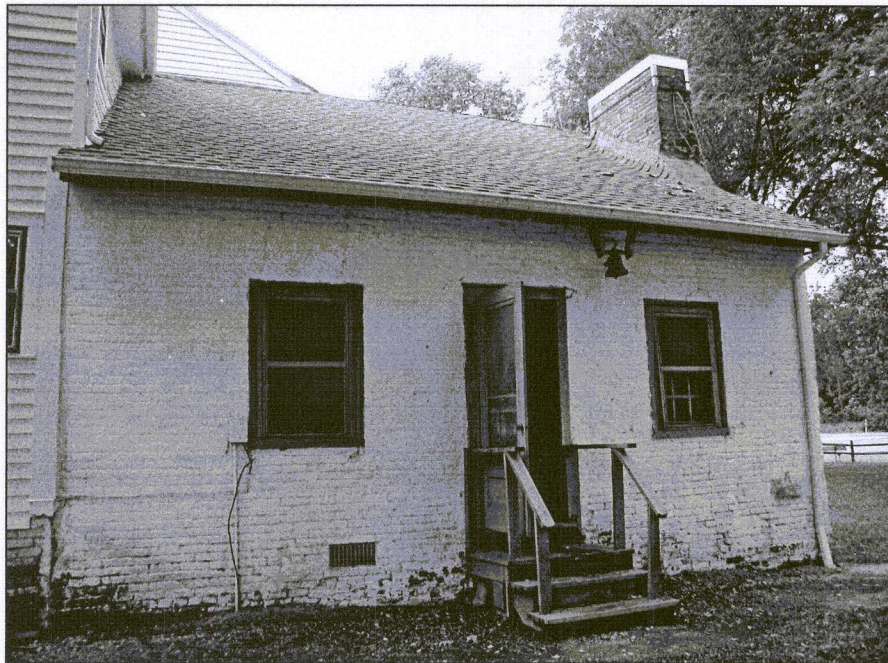
Figure 11. Northeast elevation of Period 3, summer 2002. The chimney stack noted above appears to the right of the photo. Several courses of brick were removed in 2000 due to the instability of the stack.

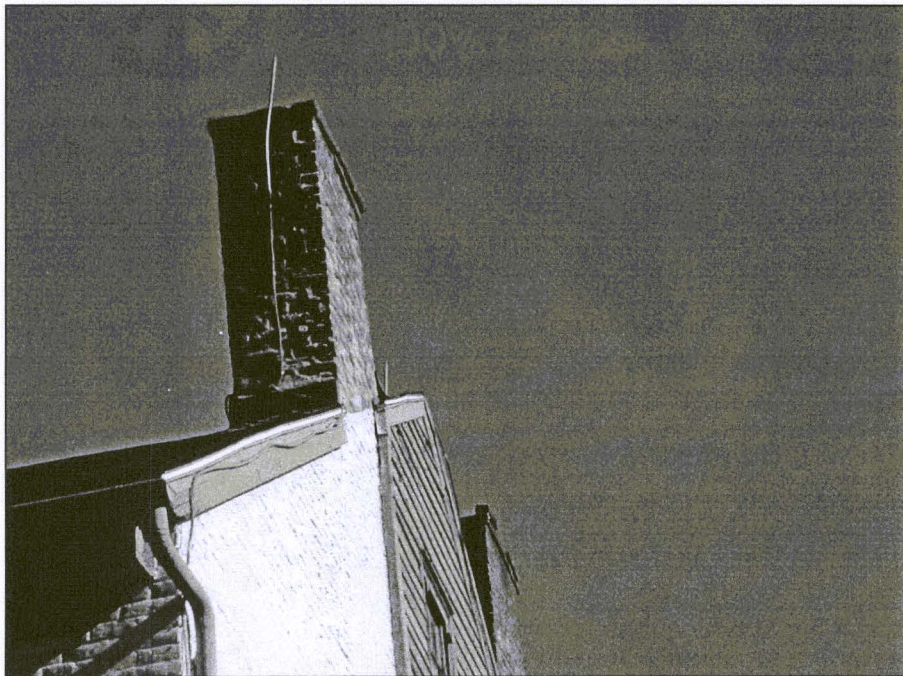
Figure 13. Details of corbelling (Period 2 foreground) and missing bricks (Period 1) on the Manor House stacks.

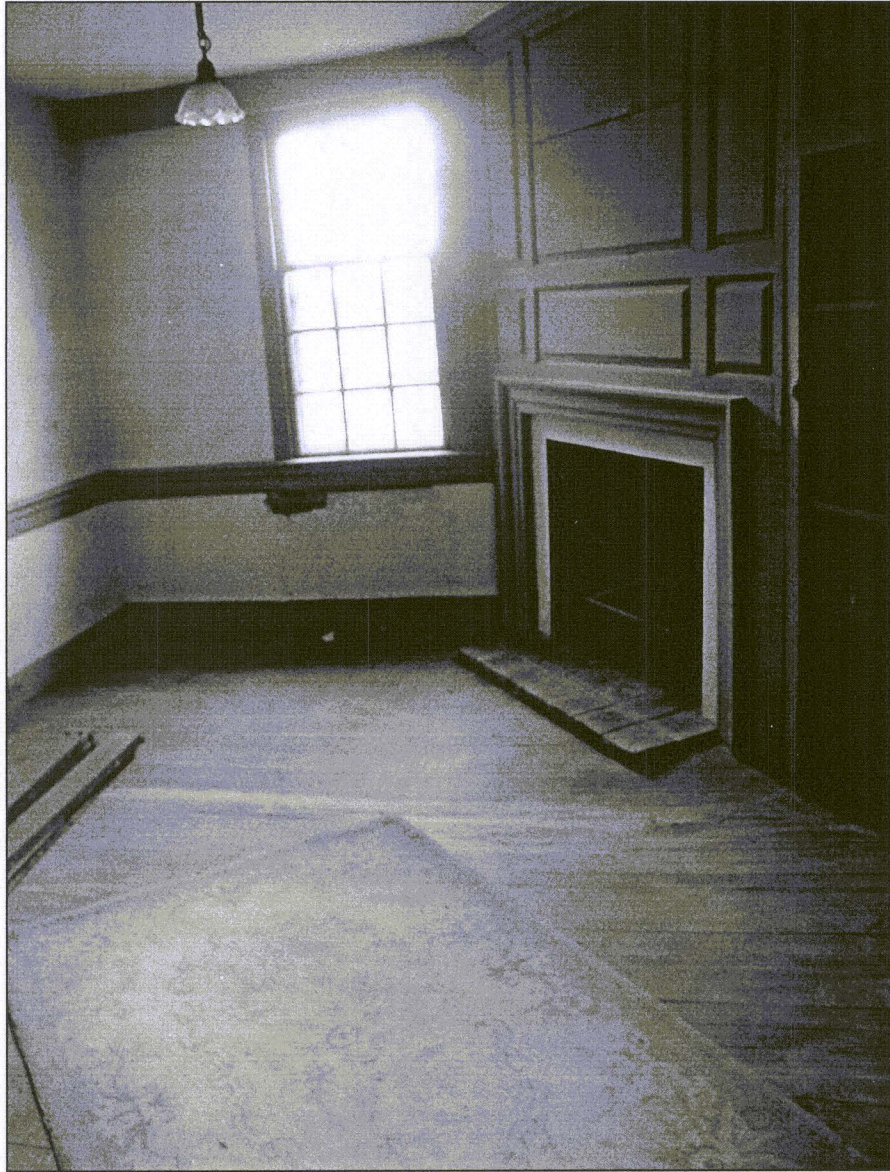
Figure 30. Period 1, second floor. Note water damage to window sill and floor.

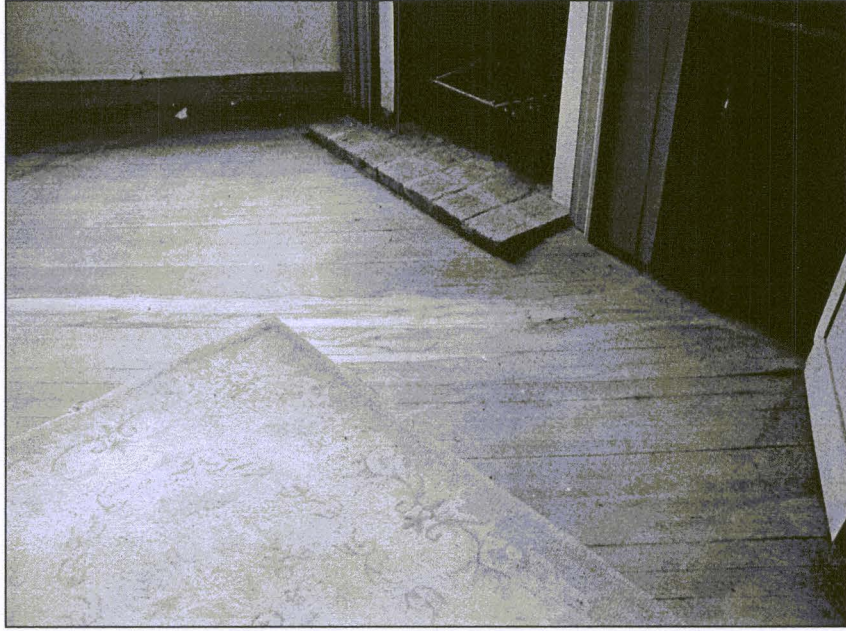
Figure 31. Detail of water damage to floor, Period 1, second floor.

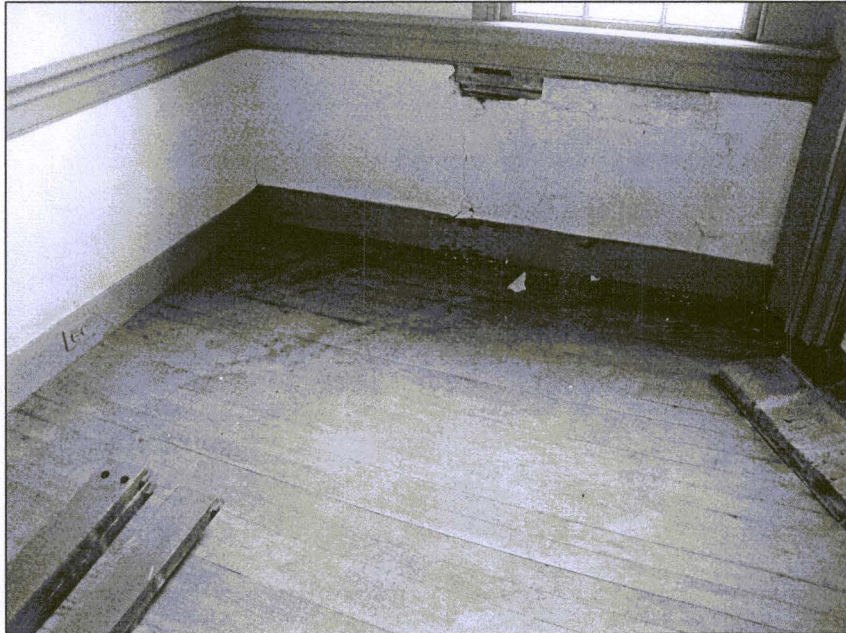
Figure 32. Detail of water damage to window sill, Period 1, second floor.

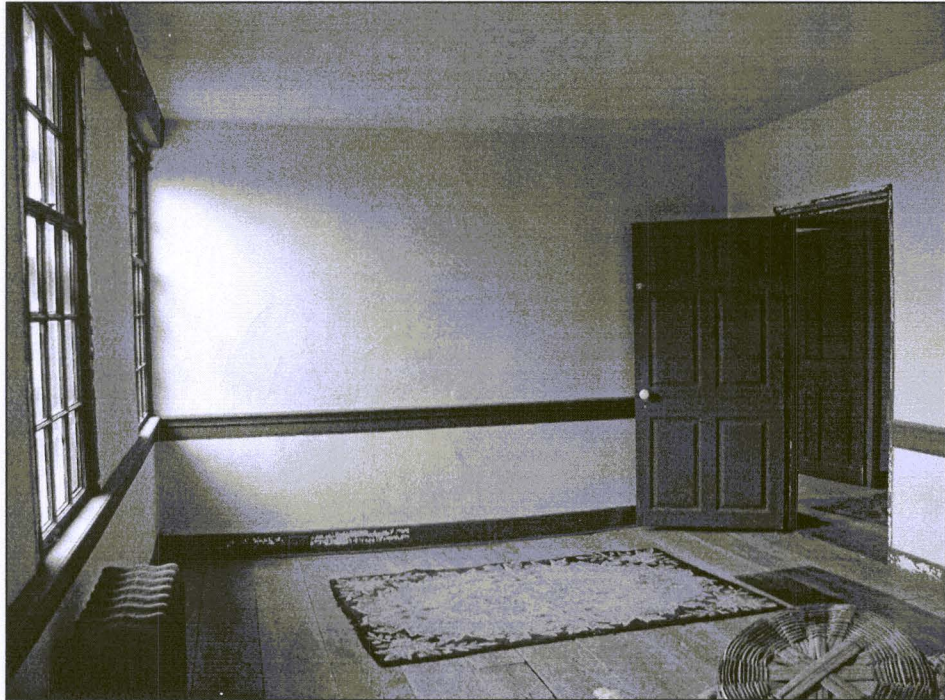
Figure 34. This room is believed to be part of the original Period 1 construction. Located on the second floor, this partition wall divides the Period 1 space, but does not line up with other walls below. Therefore, this wall is considered a “floating wall,” as it relies only on the floor joists and one plate for support.

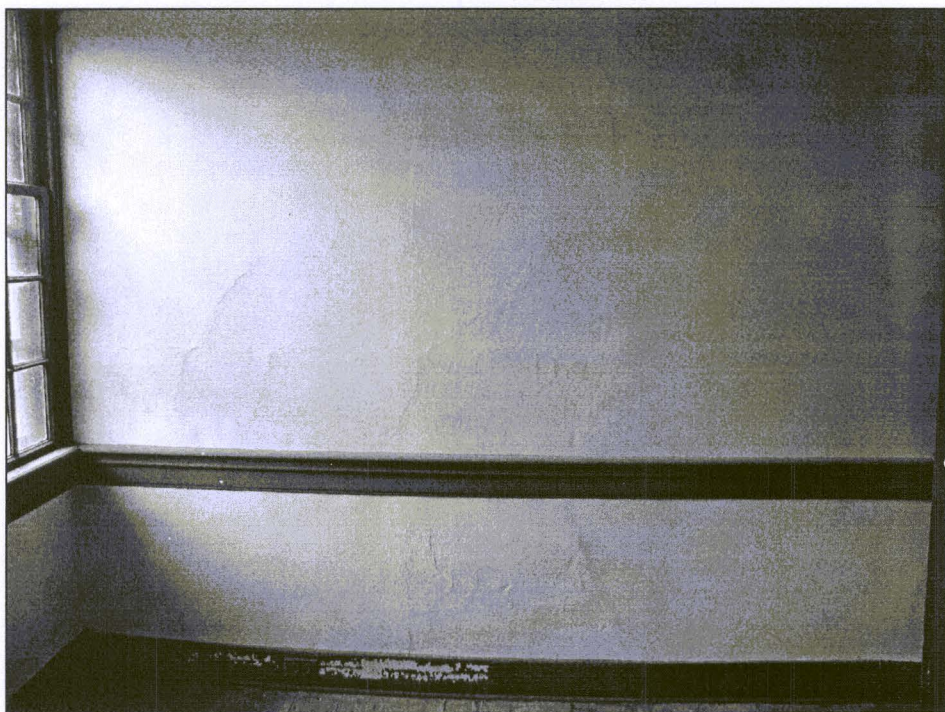
Figure 35. Close examination of this partition wall reveals evidence of a patch. This patch corresponds with notches in the flooring, on the opposite side of this wall.

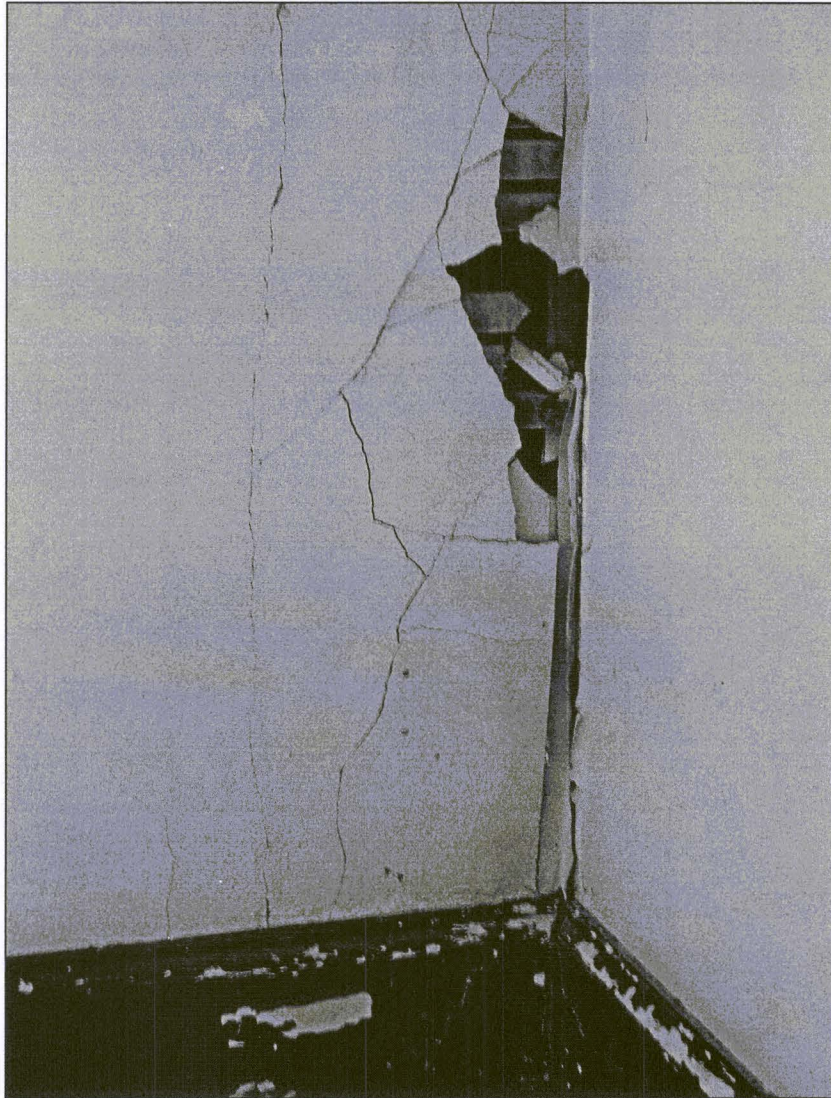
Figure 40. The east corner of Period 4, second floor, (front room) shows signs of structural stress. This detail is found in the rear right-hand corner of the room photographed above. The lath and plaster have pulled away from the corner post.
