Subject: Historic house site reviews of Kent County owned properties summation.

**Goggin house:** A site review was conducted at this location on Friday, April 21<sup>st</sup> by Paul Modesto, Jr. and Brian Ezell.

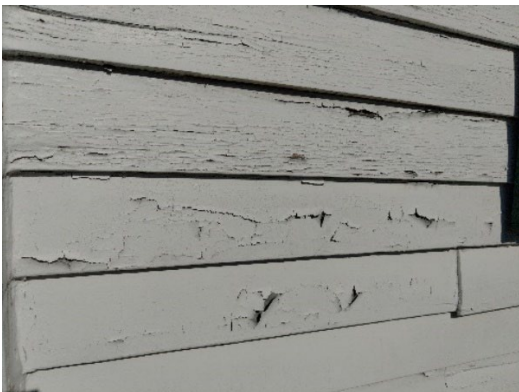
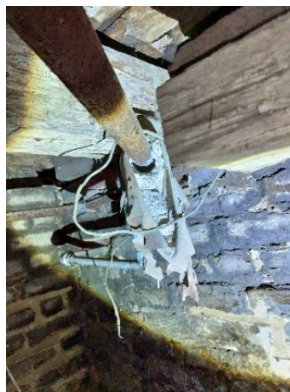
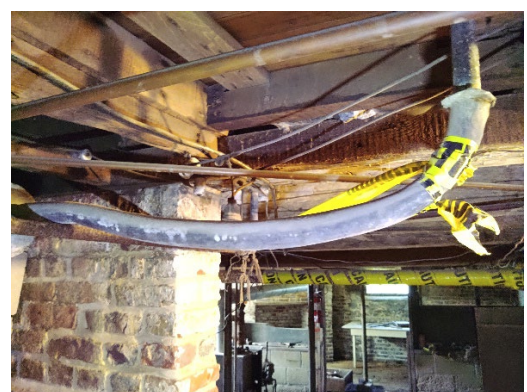
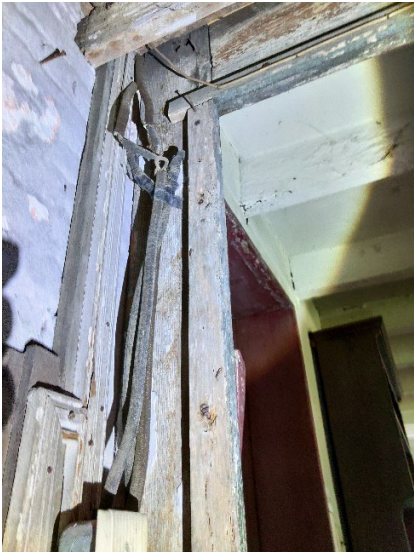
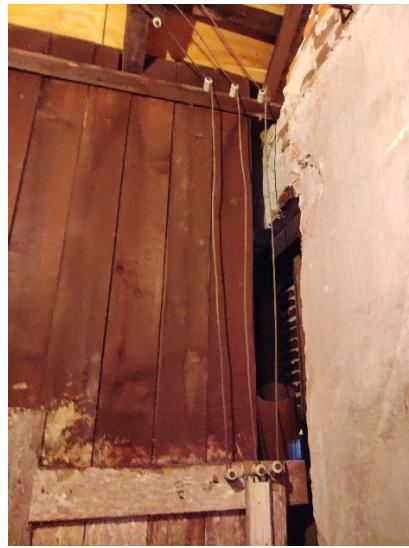
Age related health hazards are visible due to era-appropriate materials throughout the interior and exterior: lead-based paint at exterior and interior surfaces, asbestos pipe insulation in the basement, lead solder and piping is visible in the basement, and active 1<sup>st</sup> generation knob & tube wiring and fixtures. Consider remediating such items in places accessible to or involving public use.

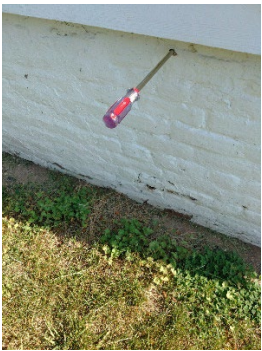
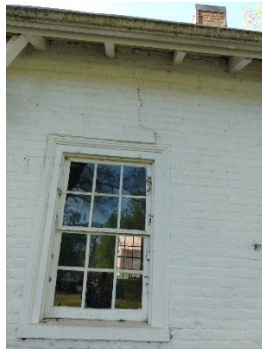
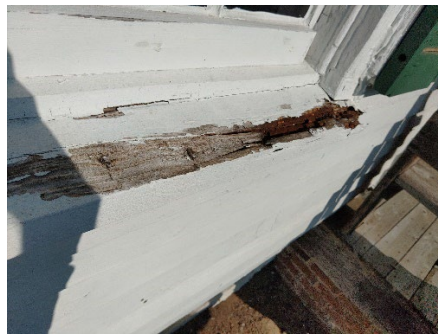
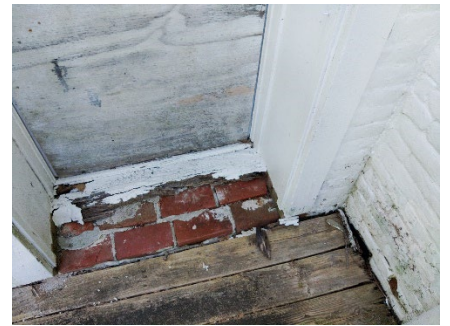
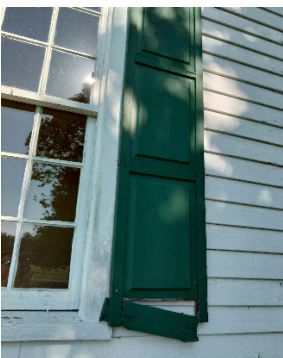
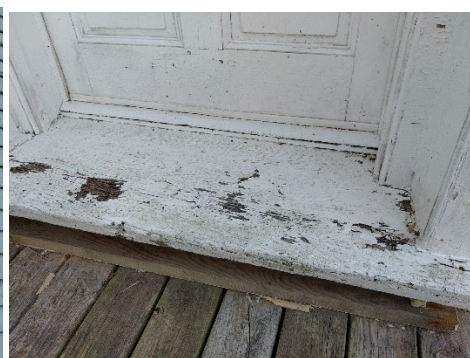
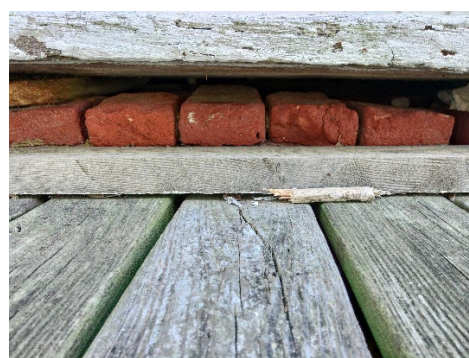
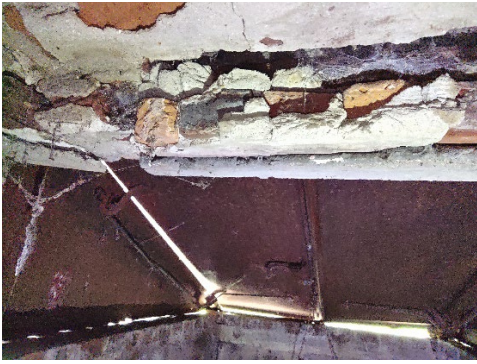
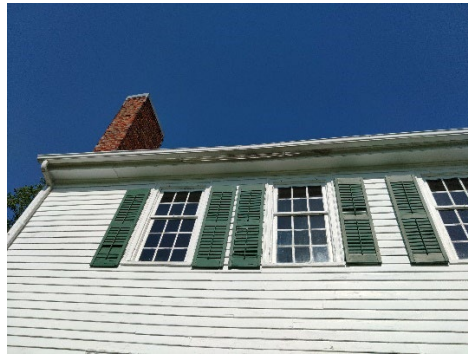
Exterior components: The exterior paint covers frequent locations of poor-condition mortar joints and deteriorated masonry surfaces, some penetrable to the interior—consider full repointing of all exterior mortar joints. Significant settlement cracks are visible at the exterior with repair. Moisture damage and/or dry rot is present at nearly all exterior wood surfaces including windowsills, door thresholds, shutters, front porch members, right side ramp, and rear landing—such items should be replaced or repaired if possible. The rear entry doors/jams have damage present—these should be repaired where possible or replaced. No support is present below the rear entry door 18" deep threshold; no lintel or passthrough frame is present at the opening in the triple wythe brick wall from the basement to the Bilco door—provide shoring by design. Gutters need repair or replacement, potentially fascia boards are damaged or deteriorated.

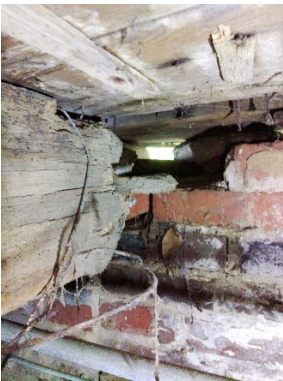
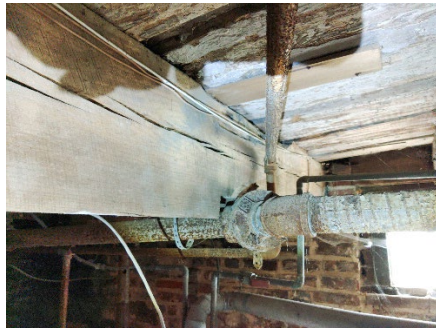
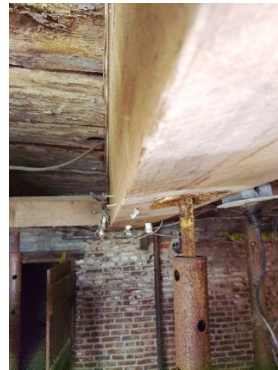
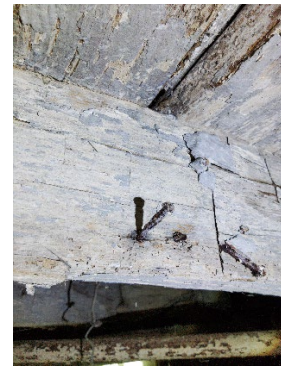
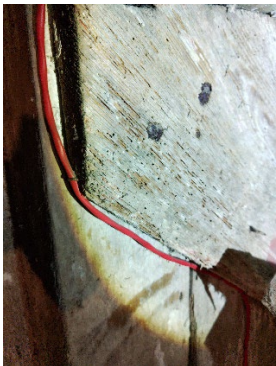
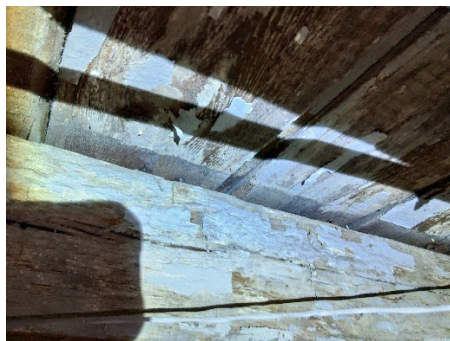
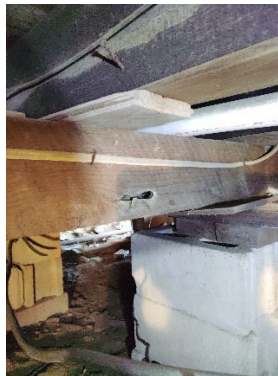
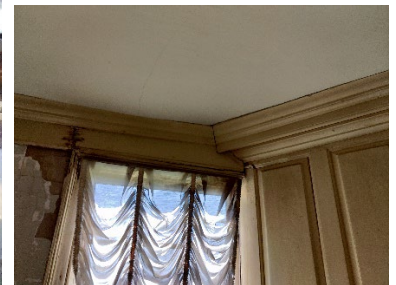
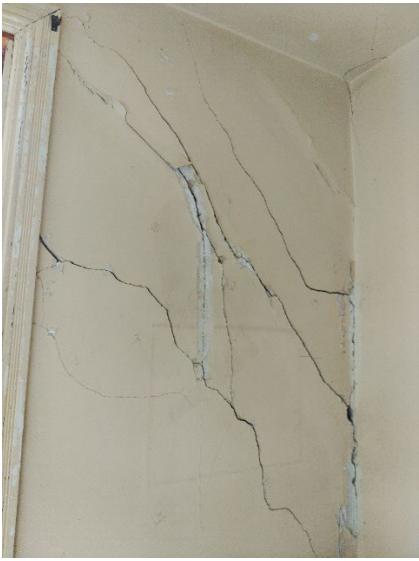
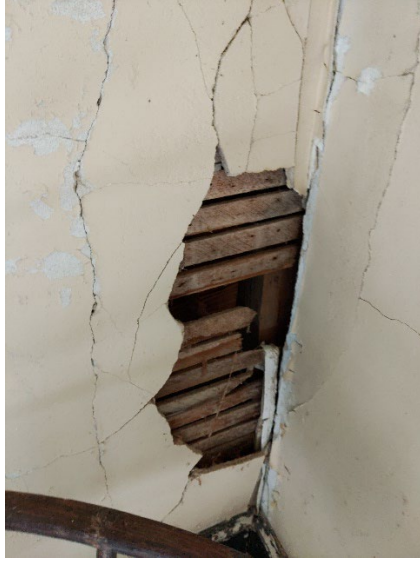
Interior components: Evidence of moisture penetration is present at multiple locations of the ceilings, exterior walls, and trim. Reinforcement and shoring are present at multiple first floor beams throughout the basement and crawlspaces; however, gaps between framing and planks are present. Daylight is visible in various locations of the foundation walls with evidence of pest and moisture entry. Most areas of the foundation interior mortar joints have been repointed, some signs of deteriorating mortar joints and some brick dust is present. Several floor beams visible in the foundation space are damaged from moisture, powder post beetles, mechanical alteration, or combination of the three. The rear stairwell for the basement and servants' quarters have loose/deteriorated treads. Settlement cracks are present throughout the interior walls and ceiling plaster & lath at all levels. Some sections of plaster and lath have fallen or appear ready to fall. No insulation is visible in the floors, walls, or ceilings.
